“Measuring Water Quality Improvements”

3rd California NPS Conference

Monitoring Benthic Macroinvertebrates at Several Putah Creek Restoration Sites

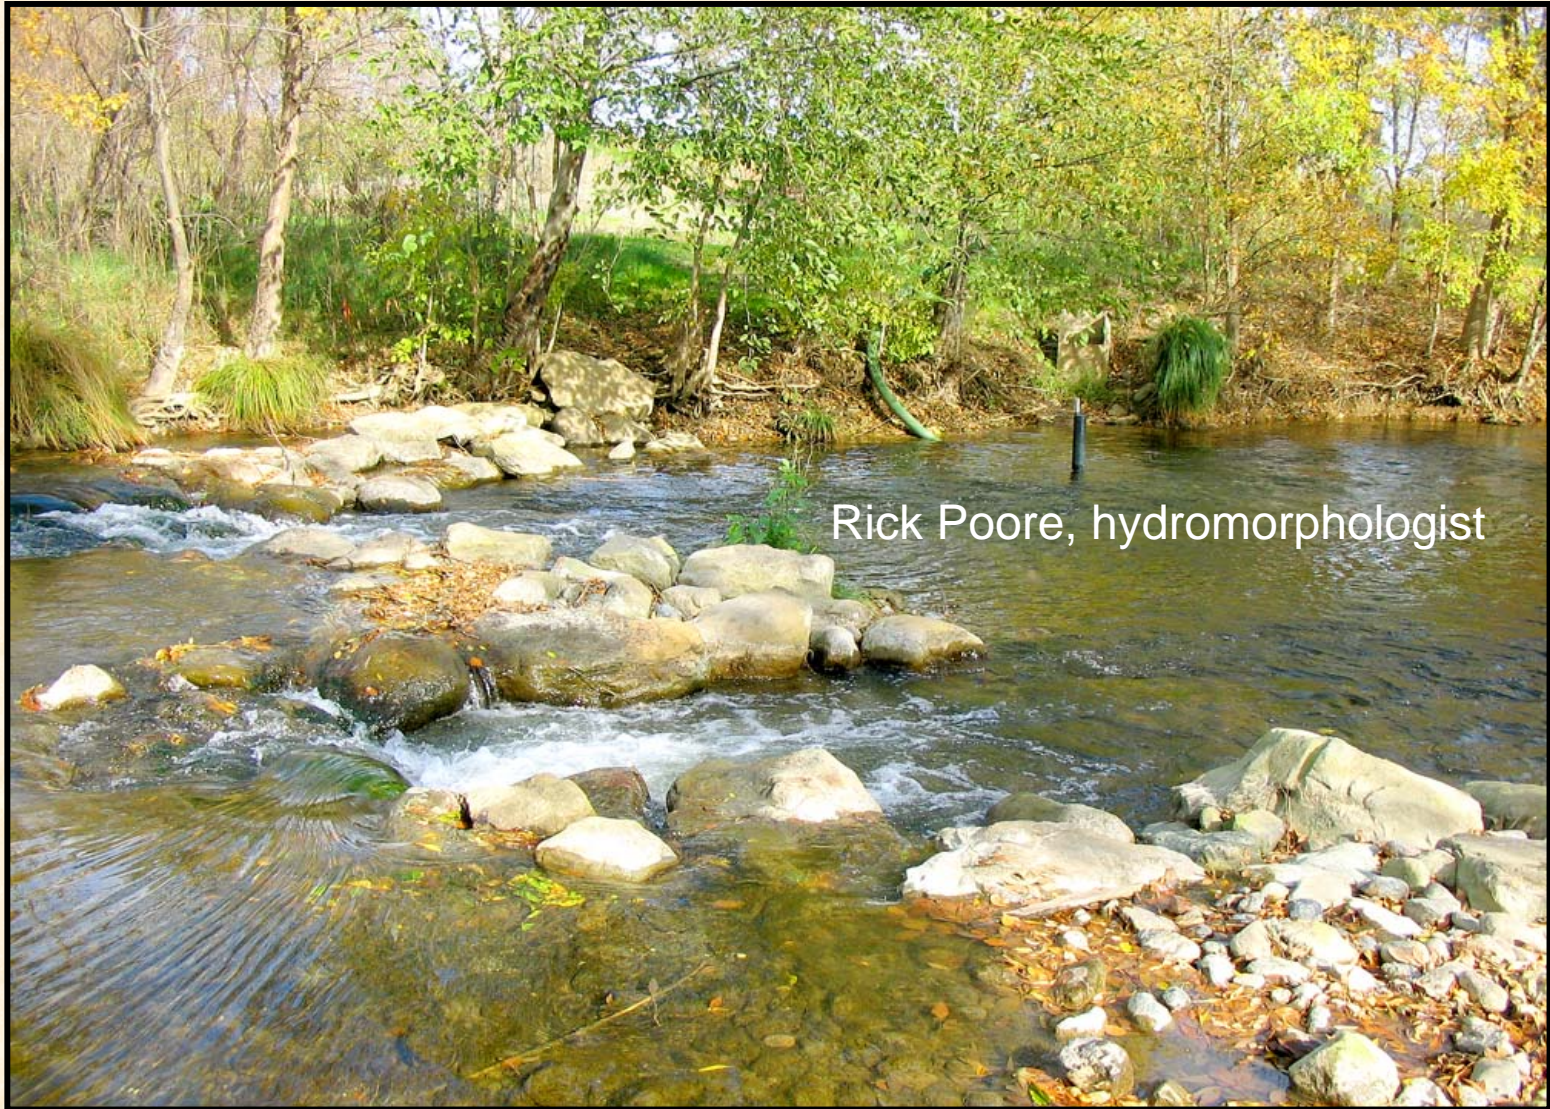
Hasbrook "W" Weir

Weir has withstood 14,000 CFS

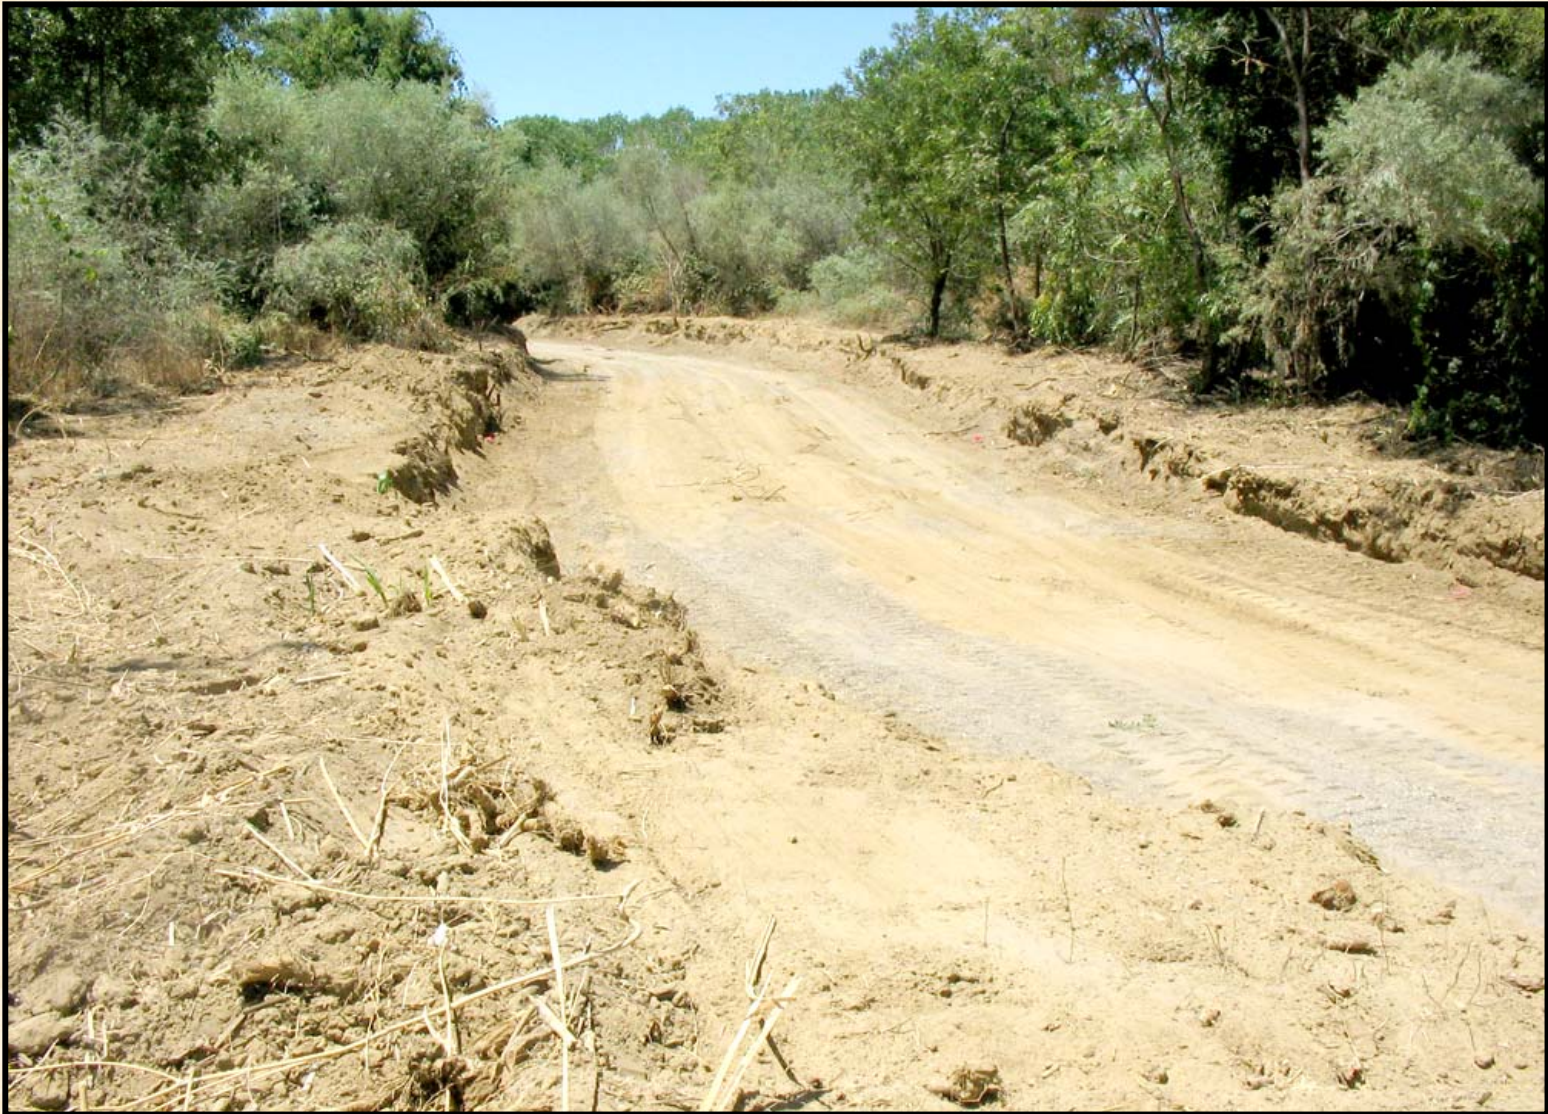
Design Channel – Locate original creek bed

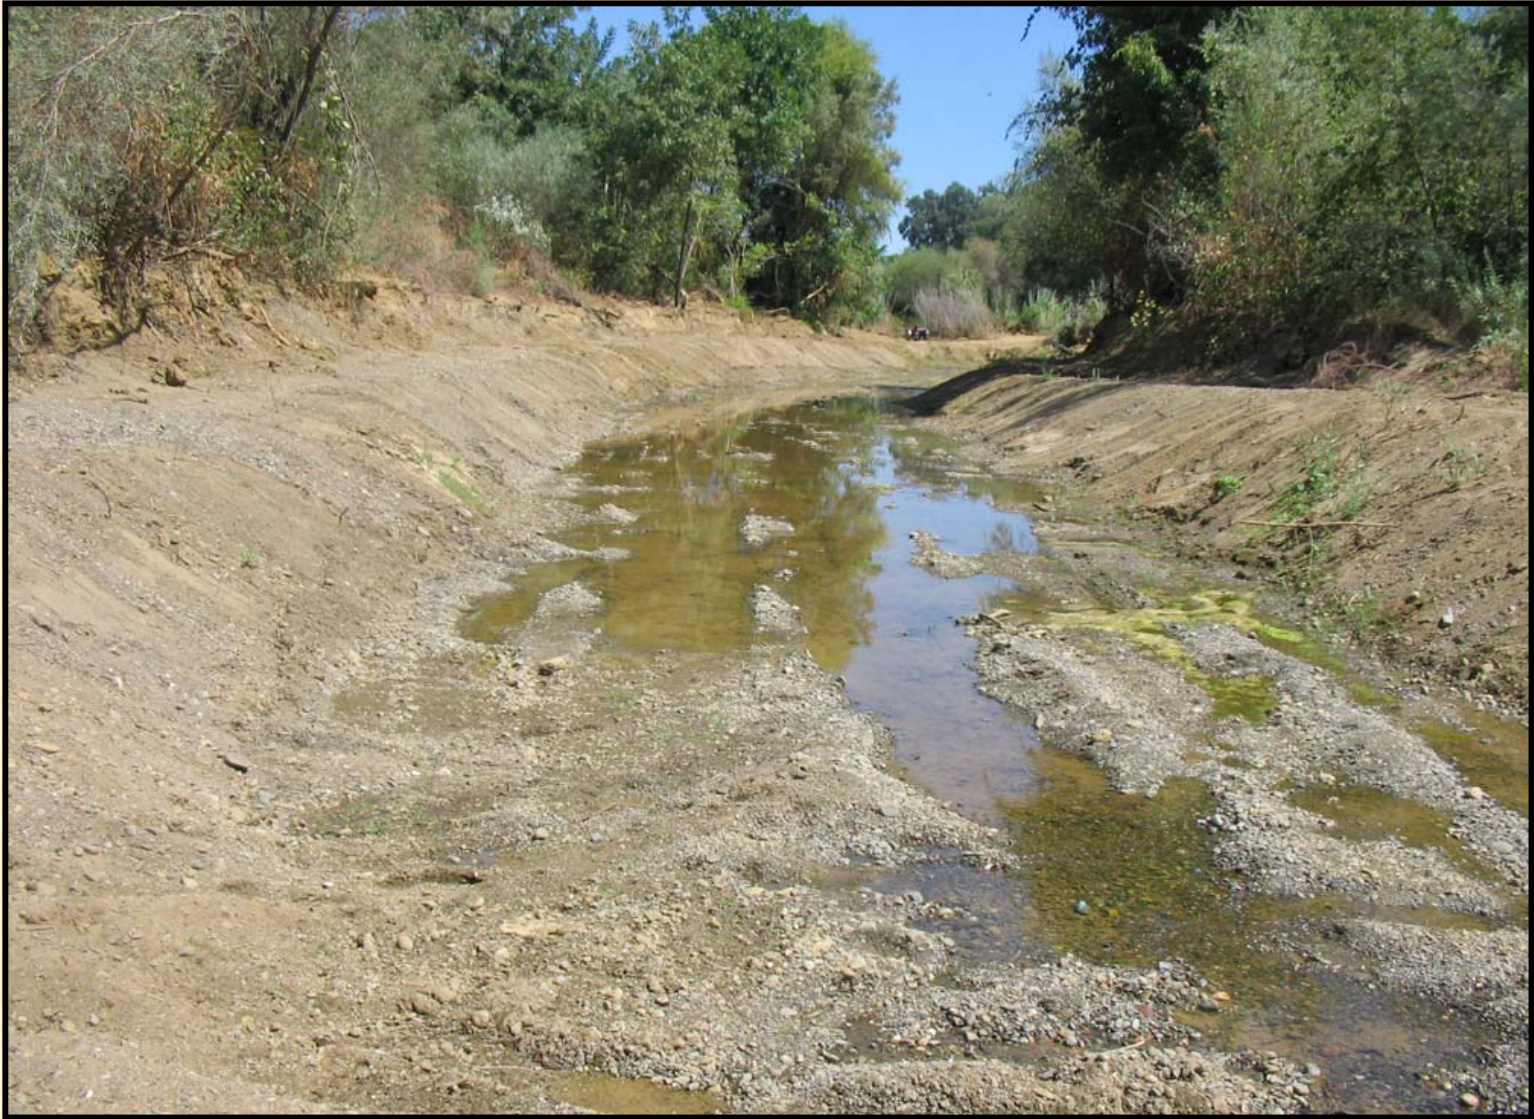
Dry Creek Design Channel

Re-aligning 1000 feet of creek bed

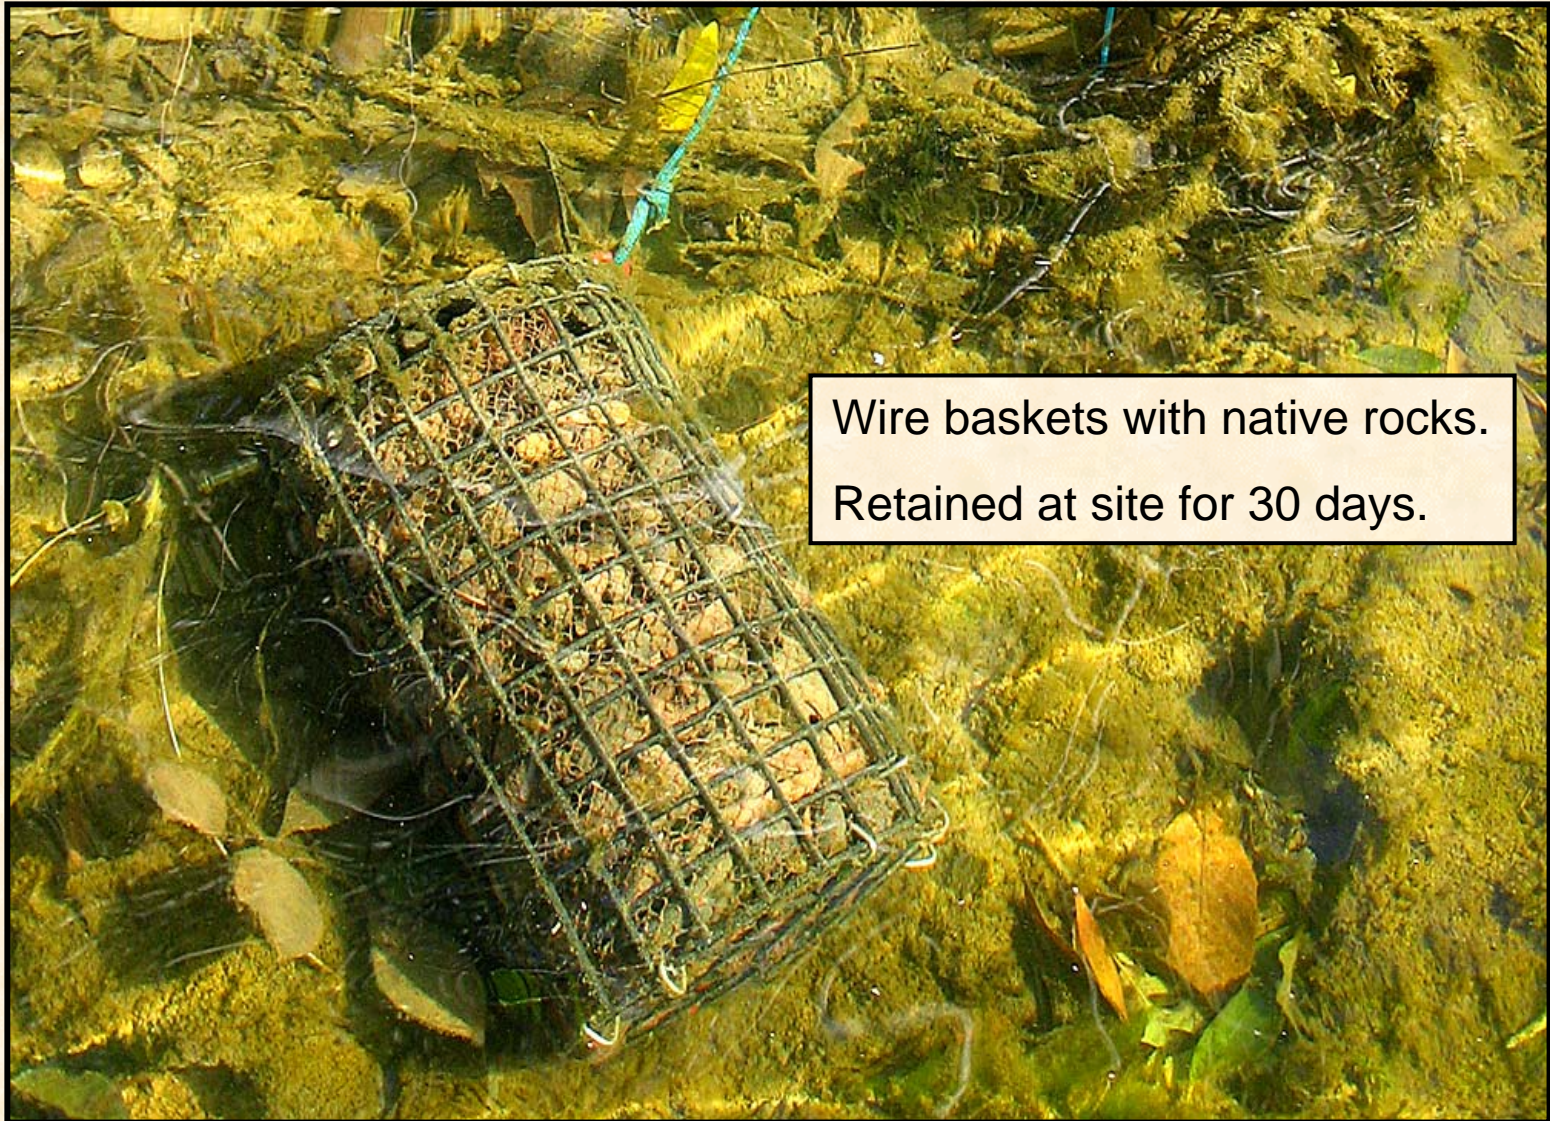
Invertebrate Monitoring in Restoration Projects

Wire baskets with native rocks.
Retained at site for 30 days.

Matches species caught with other monitoring techniques.

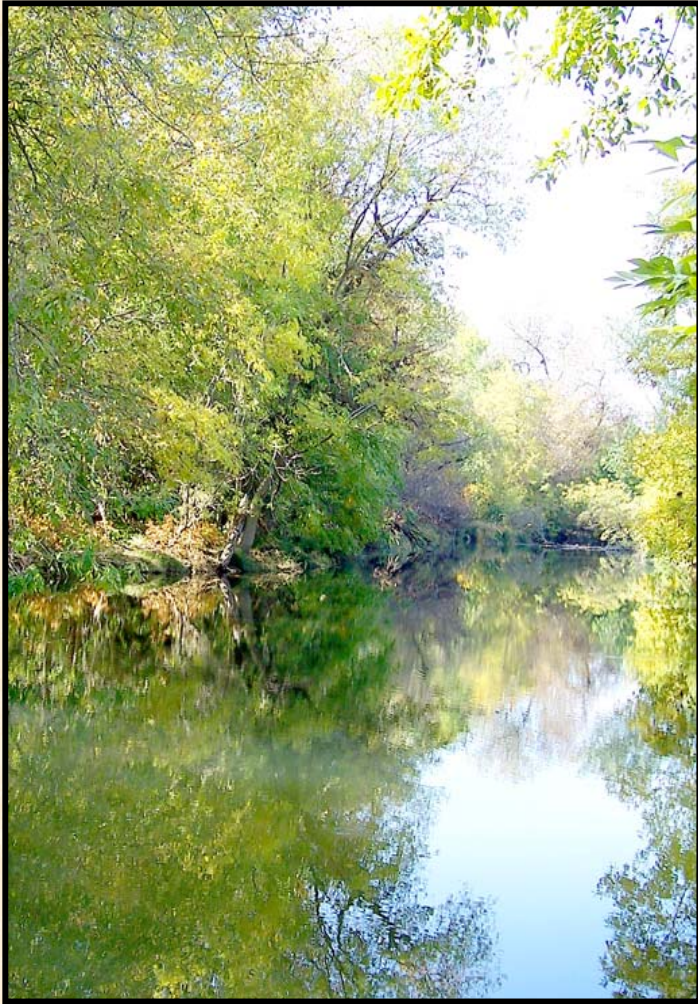
Preliminary Results - Hasbrook

58 invertebrates / basket

275 invertebrates / cu.ft.

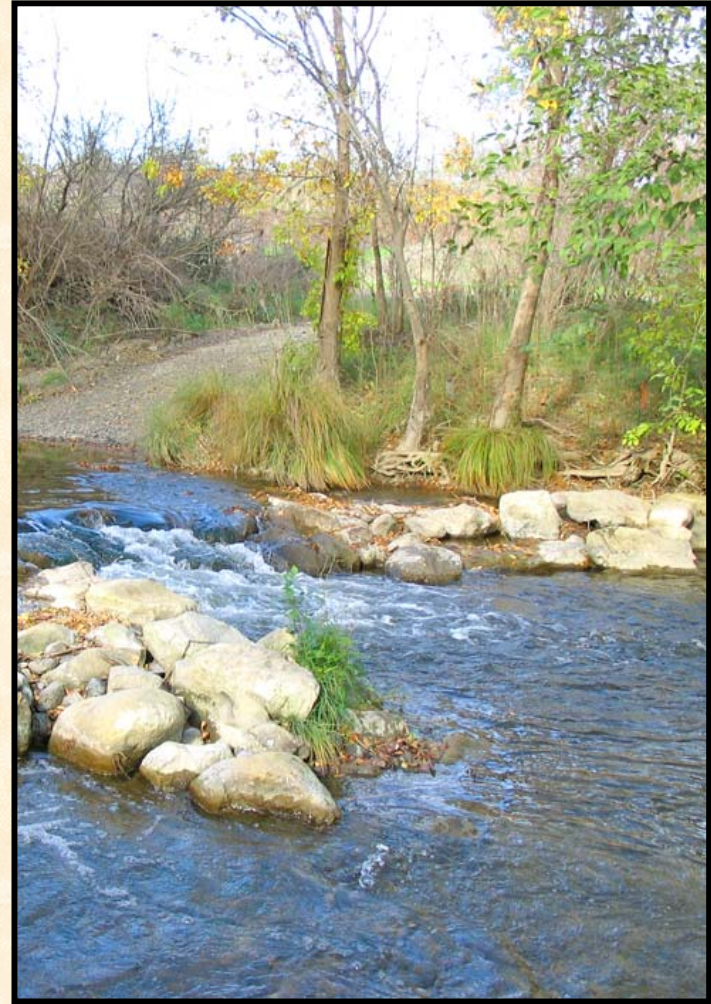
1819 Invertebrates / basket

8617 invertebrates / cu ft.

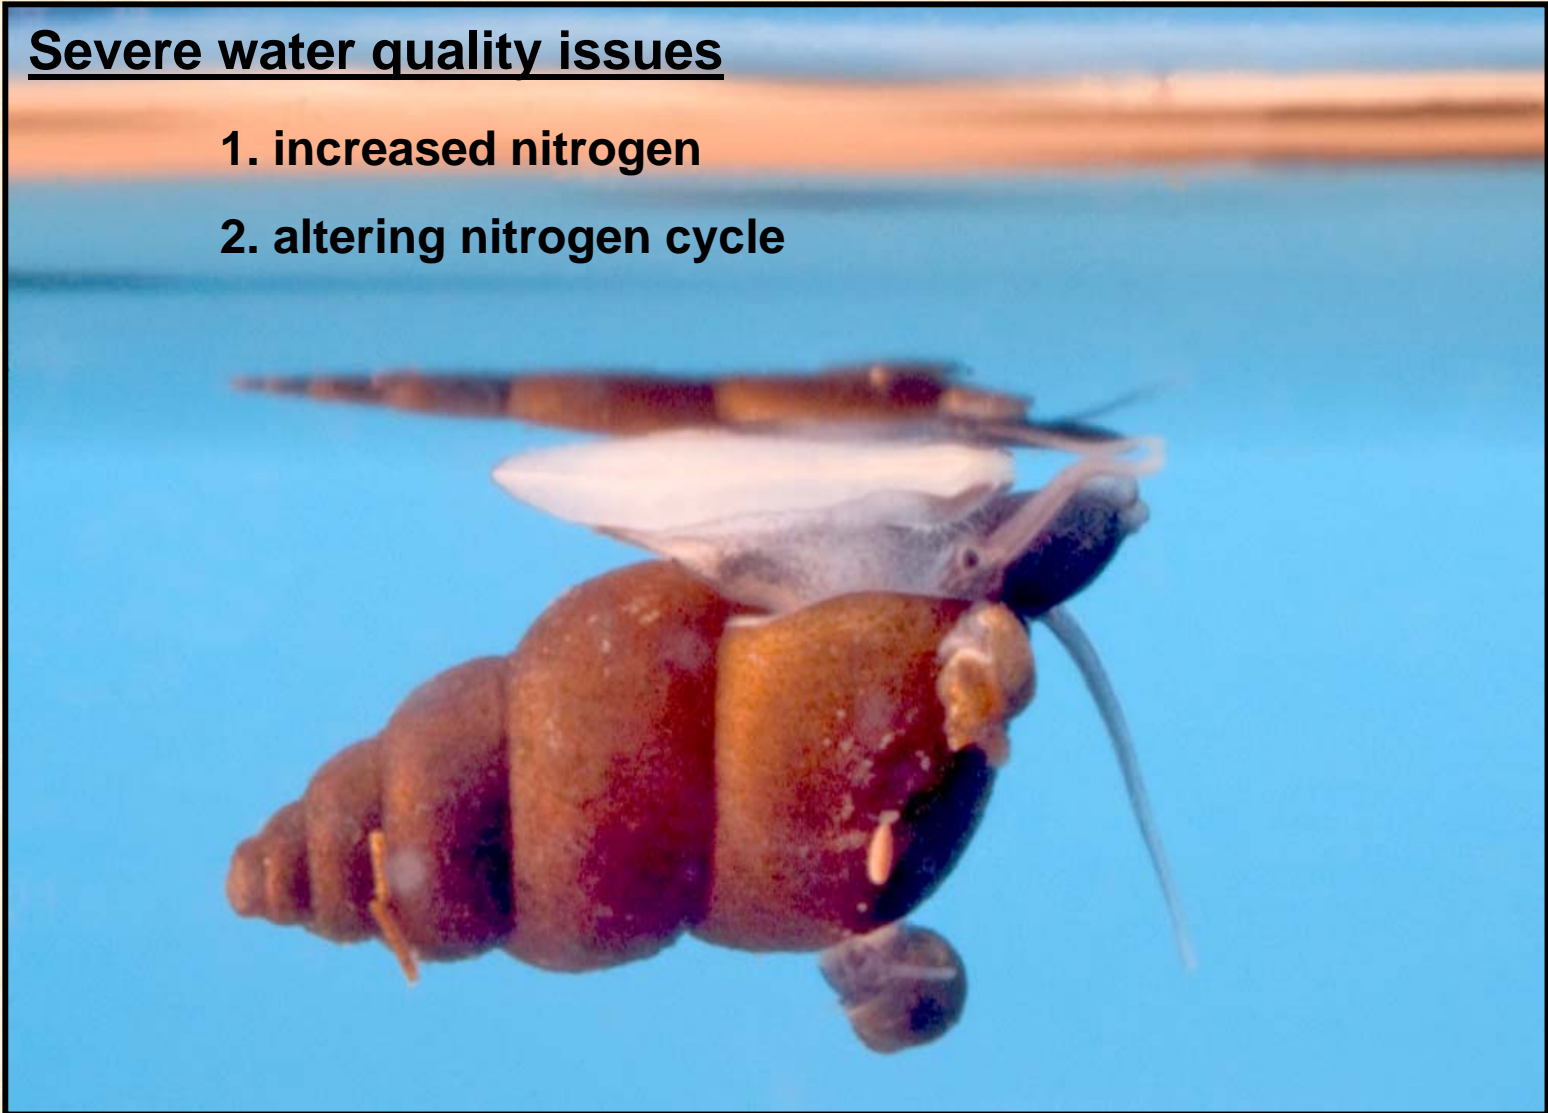
New Zealand Mudsnail Infestation

Severe water quality issues

1. increased nitrogen
2. altering nitrogen cycle

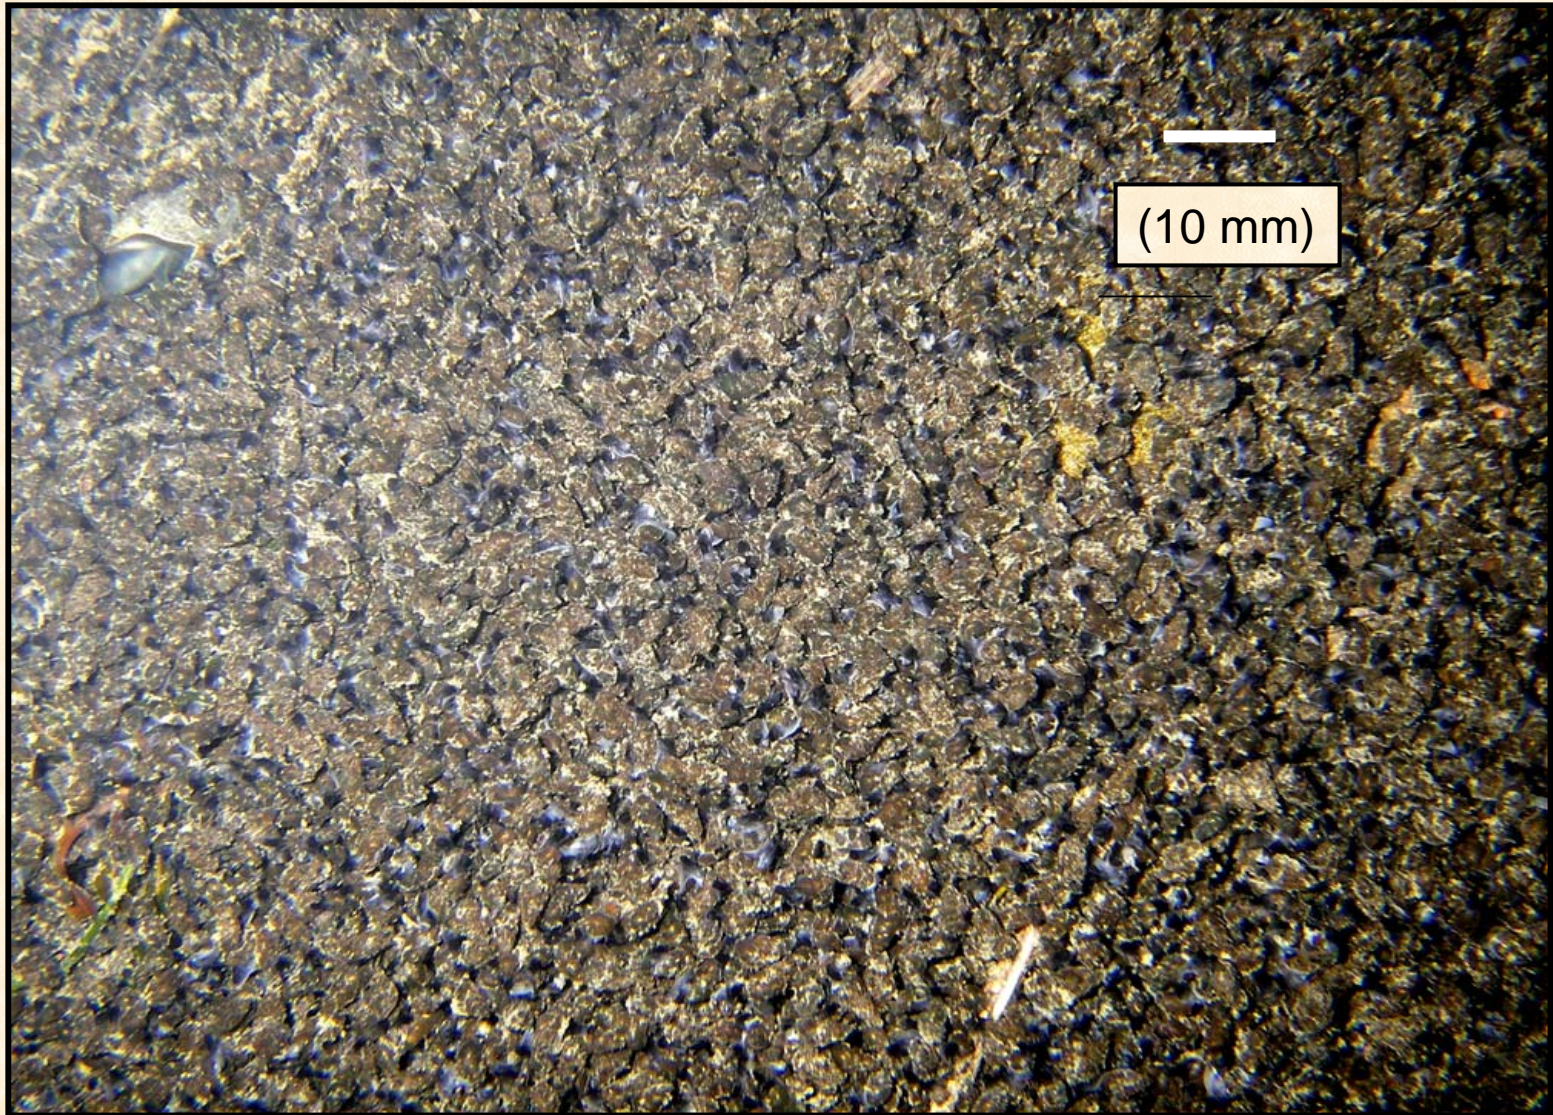
High Density – 500,000 NZMS / sq. m
